Radio Frequency Interference

Identifying and Preventing Radio Noise

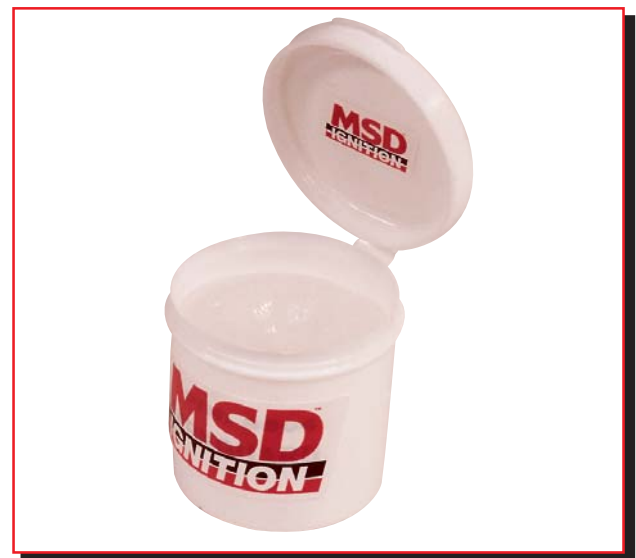
Figure 1 - MSD Spark Guard.

MSD offers a dielectric grease called Spark Guard. It is available as PN 8804. This grease reduces the chances of voltage leaks which can cause radio noise. Plus, it helps with plug boot installation and removal while preventing any chance of moisture build up inside the boot.

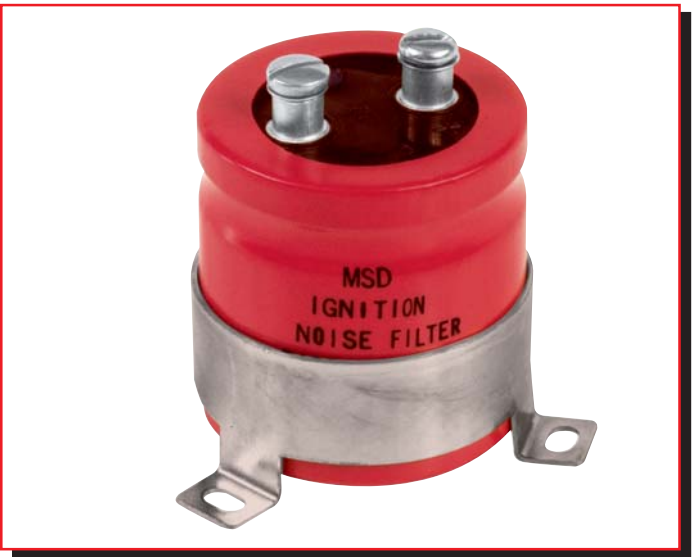
Figure 2 - MSD Noise Filter PN 8830.

The Noise Capacitor will act like a filter on the heavy power supply wires of the MSD. The MSD will draw its power through the filter keeping all of the other accessories separate which prevents supply line noise. A side benefit is that the Capacitor will protect the MSD Ignition from voltage spikes or current surges.

Supply Line noise is caused by varying loads of the vehicle's supply voltage. These variances are amplified through the radio's 12 volt supply wire and are heard through the speakers. Supply line noise will be audible on AM and FM as well as during tapes or CDs. For Supply Line noise, the MSD Noise Capacitor, PN 8830, will help.

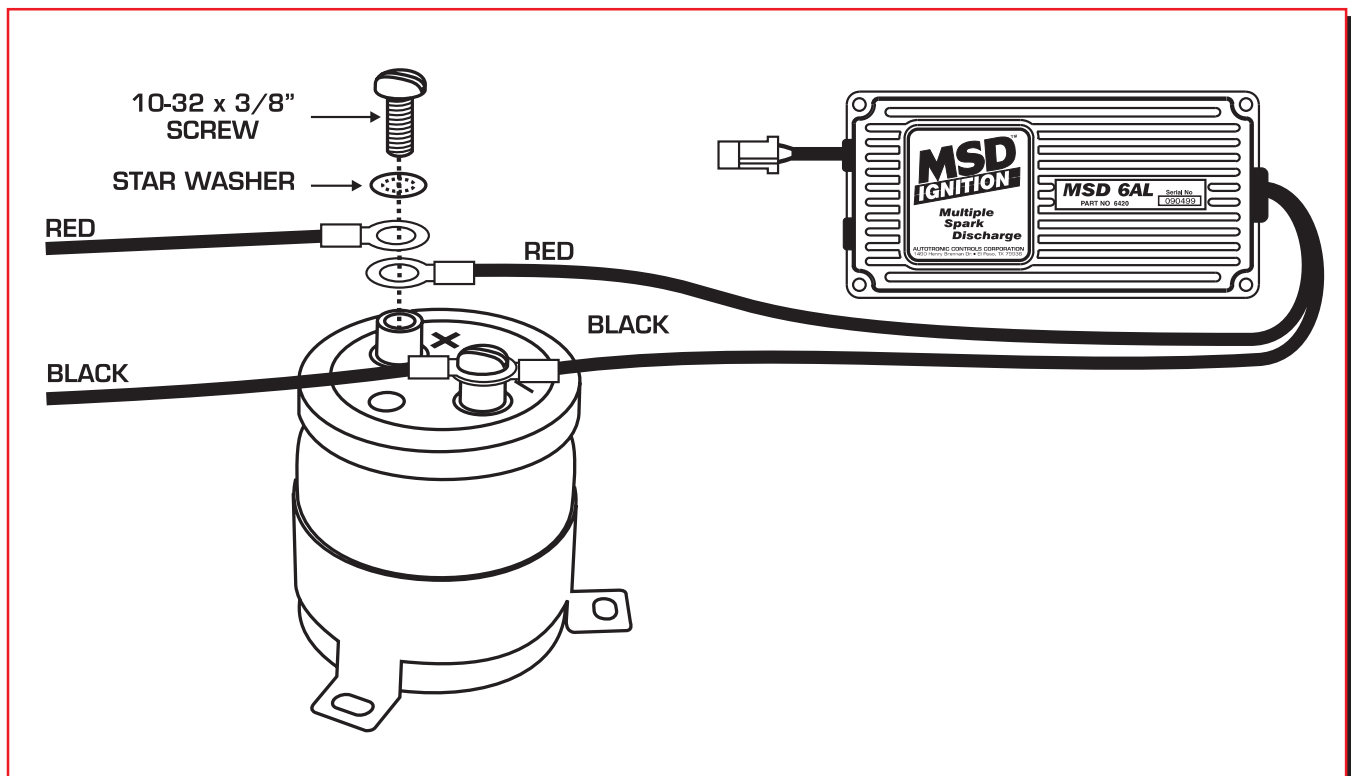
Figure 3 - Installing the MSD Noise Filter Capacitor PN 8830

1. For best results, it is recommended to mount the Capacitor as close as possible to the MSD Ignition Control. Find a secure mounting point and mark the location of the mounting holes. Use a 3/16" bit to drill the holes and use the supplied screws to mount the Capacitor.
2. It is recommended to cut the MSD wires and install high quality Ring Lug terminals. The MSD power wires are 12-gauge.
3. Attach the Red wires to the positive terminal and the Black wires to the negative terminal as shown in Figure 3.
